DEPARTMENT OF TRANSPORTATION**DIVISION OF ENGINEERING SERVICES**

Contract #: 04-0120F4Cty: SF/ALA Rte: 80 PM: 13.2/13.9File #: 1.28**WELDING INSPECTION REPORT****Resident Engineer:** Siegenthaler, Peter**Address:** 333 Burma Road**City:** Oakland, CA 94607**Report No:** WIR-021022**Date Inspected:** 24-Feb-2011**Project Name:** SAS Superstructure**OSM Arrival Time:** 700**Prime Contractor:** American Bridge/Fluor Enterprises, a JV**OSM Departure Time:** 1530**Contractor:** American Bridge/Fluor Enterprises, a JV**Location:** Job Site

Caltrans Office of Structural Material (OSM) Quality Assurance Inspector (QAI) Joselito Lizardo was present at the Self Anchored Suspension (SAS) job site as requested to perform observations on the welding of components for the San Francisco Oakland Bay Bridge (SFOBB) Project.

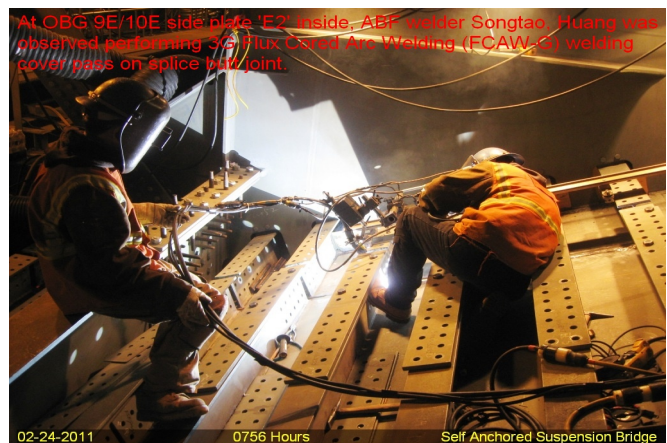
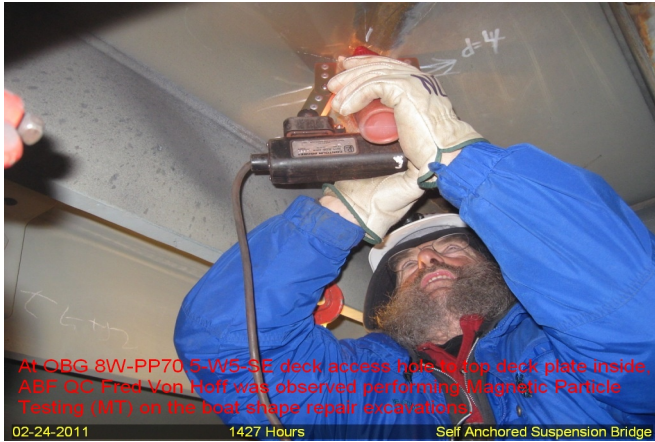
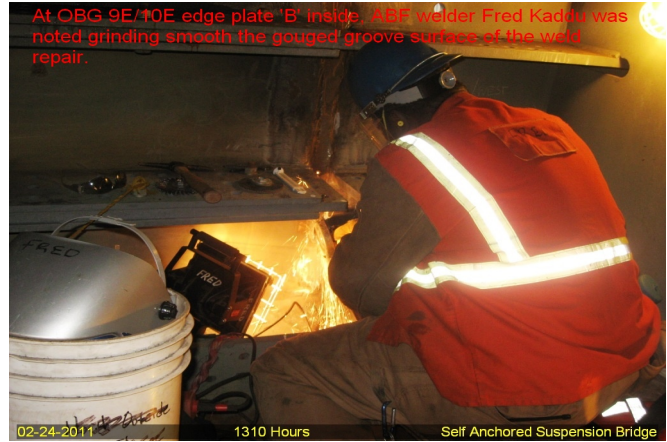
At OBG 9E/10E side plate 'E2' (2638mm to 5278mm) inside, QA randomly observed ABF/JV qualified welder Sungtao, Huang ID # 3794 continuing to perform CJP groove (splice) welding fill pass to cover pass on the splice butt joint after fixing the Bug-o remote controller. The welder was observed perform automatic welding in the 3G (vertical) position utilizing a dual shield Flux Cored Arc Welding (FCAW-G) with E71T-1M, 1/16" diameter wire electrode and implementing Caltrans approved Welding Procedure Specification (WPS) ABF-WPS-D15-3042B-1. The joint being welded has a single V-groove butt joint with backing bar. The splice joint was preheated and maintained to greater than 150 degrees Fahrenheit using Miller Proheat 35 Induction Heating System heater blankets located at the opposite side of the plate prior/during welding. During welding, ABF Quality Control (QC) Steve Jensen was noted monitoring the welding parameters of the welder. At the end of the shift, cover pass welding was completed and according to the welder he is moving to OBG 9W/10W side plate 'E' inside for his next welding work.

At OBG 8W-PP70.5-W5-SE deck access hole to top deck plate inside, QA randomly observed ABF/JV qualified welder Jorge Lopez perform CJP repair welding. The welder was noted excavating the three repairs using carbon air arc gouging. After gouging the three repairs, the welder smoothly ground the surface of the excavated groove and called ABF QC Fred Von Hoff for Magnetic Particle Testing (MT) prior welding. This QA has observed QC perform the MT which he found no indication during the test. Since there was no more time left to perform the

At OBG 6E-PP37.5-E5-N deck access hole infill plate to top deck plate inside, QA randomly observed ABF/JV qualified welder Han Wen Yu continuing to perform CJP groove root pass welding. The welder was observed welding in the 4G (overhead) position utilizing SMAW with 1/8" diameter E7018H4R electrode implementing Caltrans approved welding procedure ABF-WPS-D15-1010 Revision 1. The joint being welded has a double V-groove butt joint with open root. ABF Quality Control (QC) William Sherwood was noted monitoring the welding parameters of the welder. At the end of the shift, root pass welding of the butt joint at location mentioned above was still continuing and should remain tomorrow.

At OBG 2E-PP13.5-E5-N deck access hole infill plate to top deck plate outside, QA randomly observed ABF/JV qualified welder Jin Pei Wang continuing to perform CJP groove root pass welding. The welder was observed welding in the 1G (flat) position utilizing SMAW with 1/8" diameter E7018H4R electrode implementing Caltrans approved welding procedure ABF-WPS-D15-1010 Revision 1. The joint being welded has a double V-groove butt joint with open root. ABF Quality Control (QC) William Sherwood was noted monitoring the welding parameters of the welder. At the end of the shift, root pass welding of the butt joint at location mentioned above was still continuing and should remain tomorrow.

At OBG 8W/9W side plate 'E' outside, ABF welder Rory Hogan was noted continuing to prepare his welding equipment and welding cover protection. No welding was performed at this location today. Also at OBG 9E/10E edge plate 'B' inside, ABF welder Fred Kaddu was noted continuing to grind the groove of the excavated surface of the three repairs.
